REPORT CONFIRMED BY
John Treby

PROPERTY VISIT DATE
27/08/2024

PREPARED ON BEHALF OF
XXXXXX

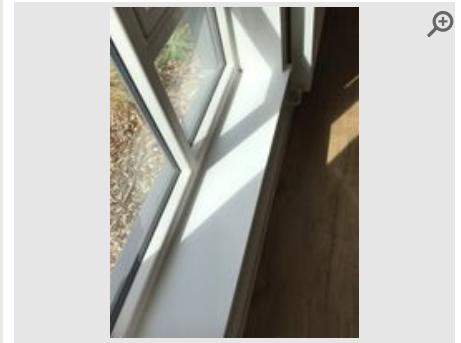
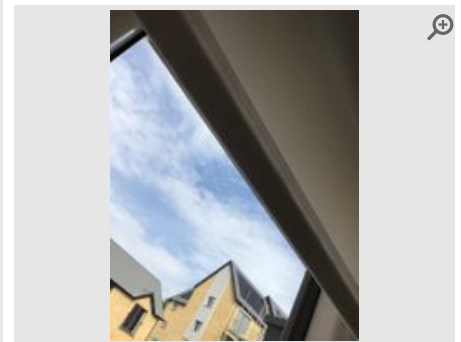
4.5 Walls	Plastered & painted white. Tiled (around worktops). Tiled splashback (behind cooker). Yellow	● Good	● Good	📷 2 photos
4.6 Windows and Sills	Standard window. 2 in total. UPVC double glazed. Clear glass. Keys not present. Chrome handle. Wooden sills. Tiled sills. Roller blind. Fabric blind. Trickle vents present. Sills free of marks. Windows intact. Frames free of marks. Opening Mechanism functioning. White blinds	● Good	● Good	📷 8 photos
Information provided by inspector: Roller blind over sink needs reseating.				
🔴 Landlord responsibility				🔧 Repair

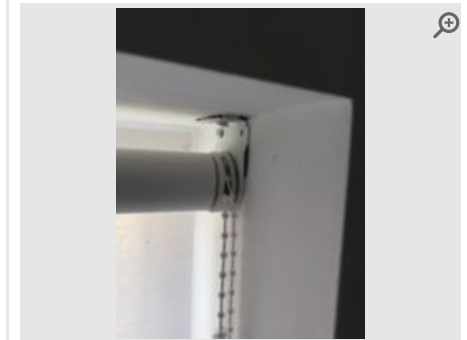
7.7 Walls	Plastered & painted white	● Good	● Good	📷 N/A
7.8 Windows and Sills	Standard window. 2 in total. UPVC double glazed. Clear glass. Keys not present. Chrome handle. Wooden sills. Roller blind. Fabric blind. Trickle vents present. Safety device present. Sills free of marks. Windows intact. Frames free of marks. Opening Mechanism functioning. White blinds	● Good	● Fair	📷 3 photos
	Information provided by inspector: Front roller blind incorrectly fitted, will not easily open.			
	🔧 Landlord responsibility			🔧 Repair

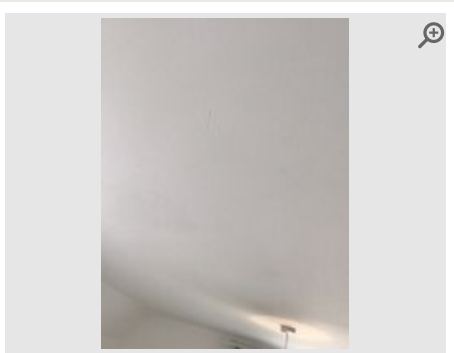
Ceiling

Item	Description	Condition	Cleanliness	Photos
11.1 General Overview	Clean & Tidy. Neutral smell/no odours evident Gouge on front of door to centre left. Front casement handle is pitted. Gouge in ceiling to centre.	● Good	● Good	📷 N/A
