REPORT CONFIRMED BY
John Treby

PROPERTY VISIT DATE
27/08/2024

PREPARED ON BEHALF OF
XXXXXX

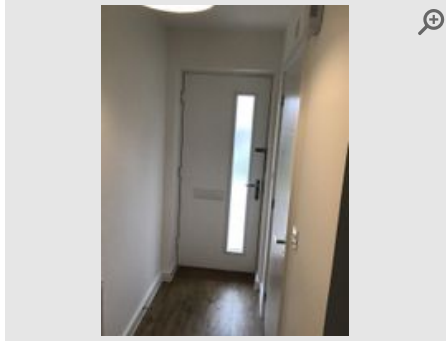
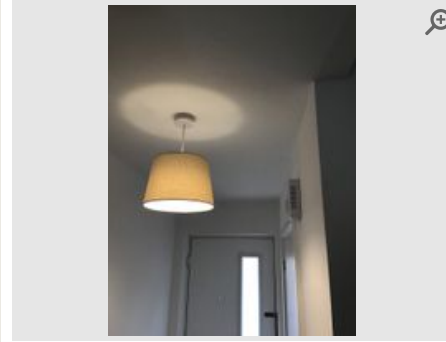
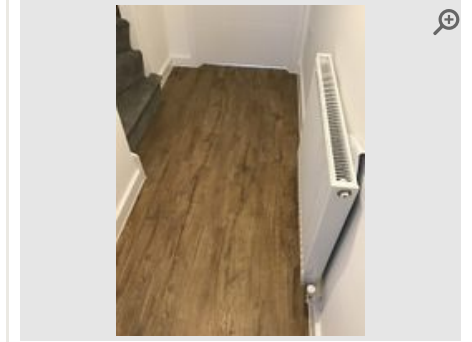
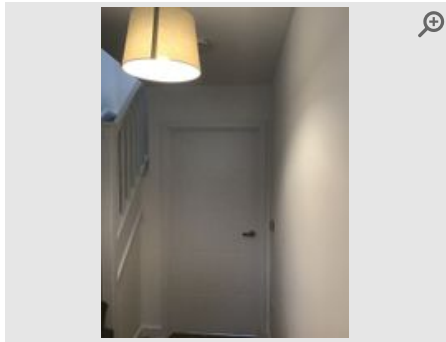
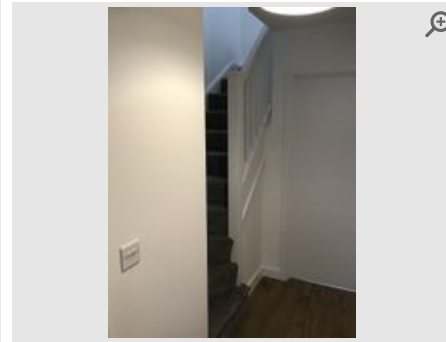
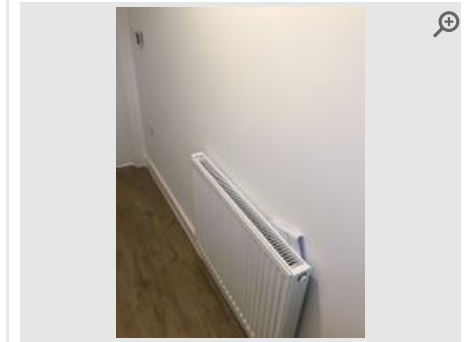
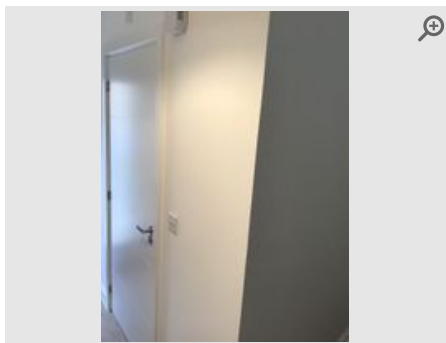
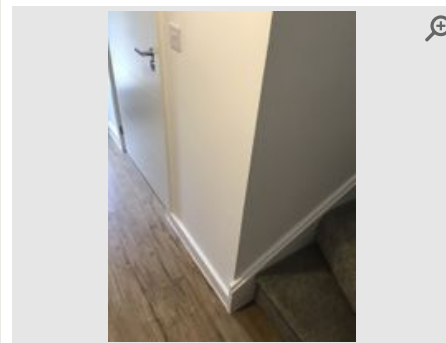
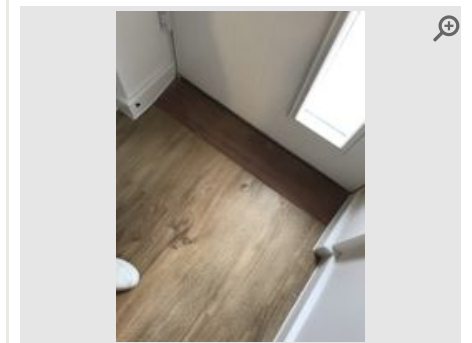
1 Entrance/Hallway				
Item	Description	Condition	Cleanliness	Photos
1.1 General Overview	Clean & Tidy. Neutral smell/no odours evident Rear of door scuffed above window. Door frame over front door is overpainted. Left wall gouged to upper left near front door. Flooring unclean.	● Fair	● Good

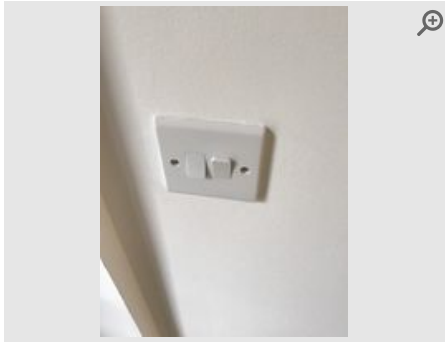
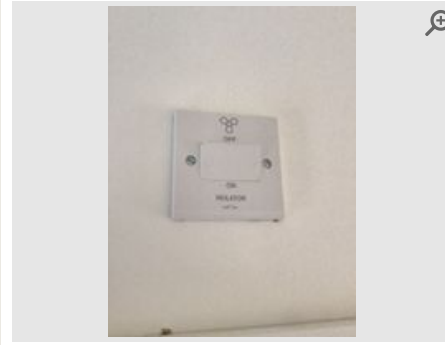
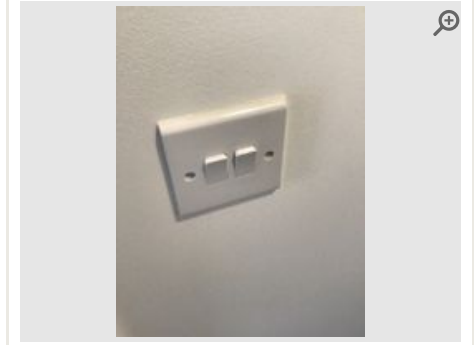
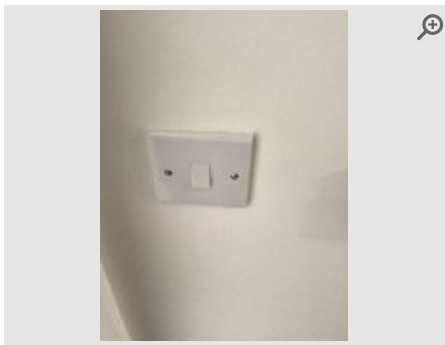
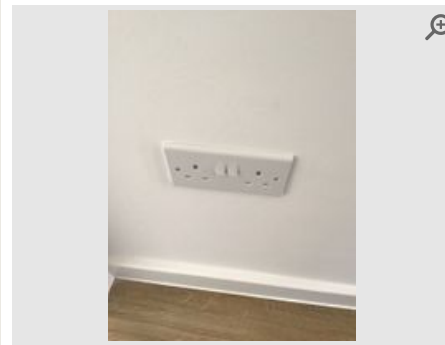
1.10 Sockets & Switches	All sockets/switches plastic. 5 in total All sockets and switches present and intact with no signs of damage.	● Good	● Good

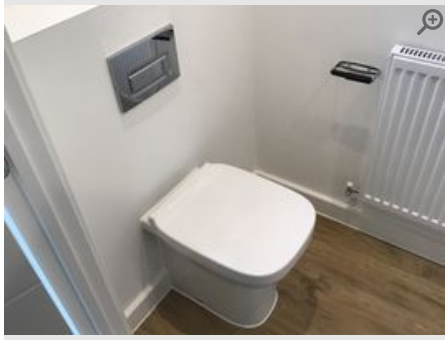
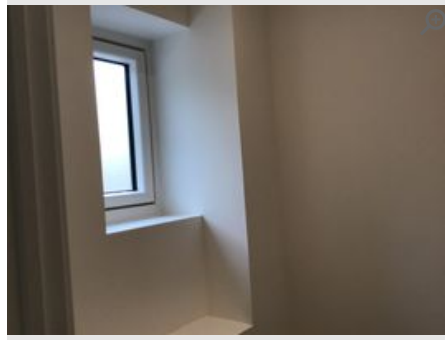
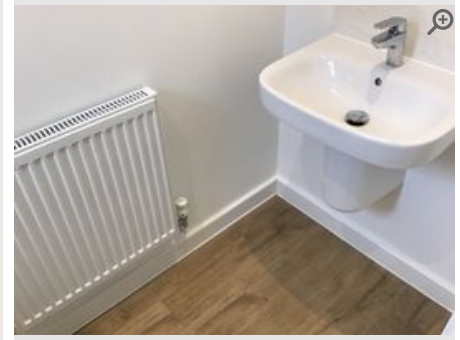
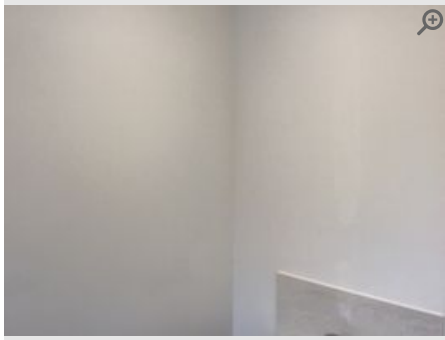
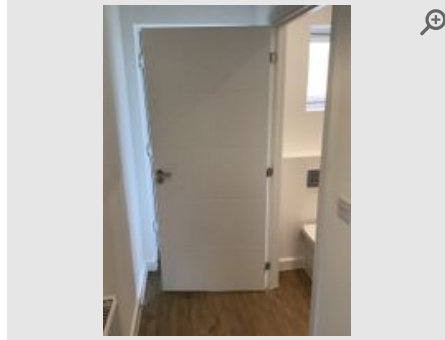
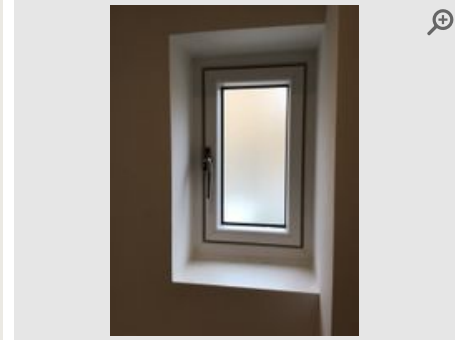
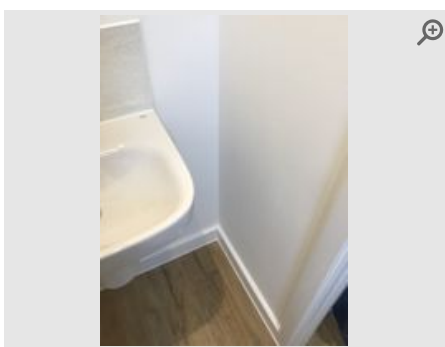
Item	Description	Condition	Cleanliness	Photos
2.1 General Overview	Clean & Tidy. Neutral smell/no odours evident	● Good	● Good

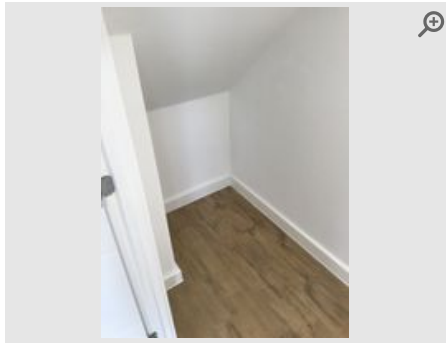
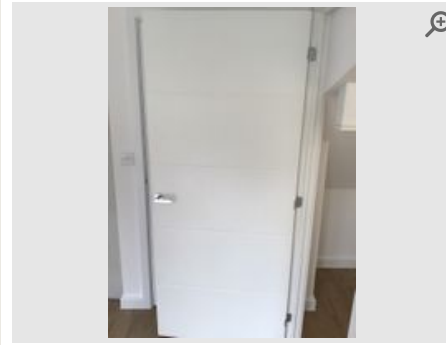
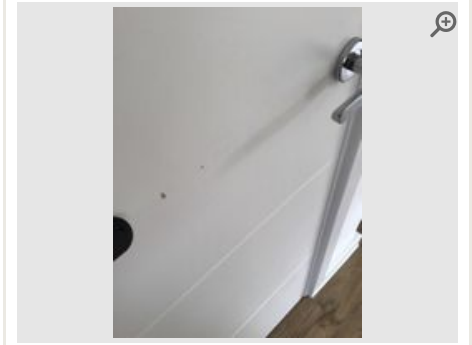
Provided by	Inspector
Captured (via App):	27/08/2024 11:40 AM
Added	27/08/2024
Reference	3.14.1

3.14 Storage Cupboard	Hinged door. Wood panelled; chrome handle. White. Chipped (front side). Fuse box present. Socket(s) present. Switch(es) present. Walls free of marks/stains. Floor free of marks/stains Light - working.	● Good	● Good	📷 3 photos

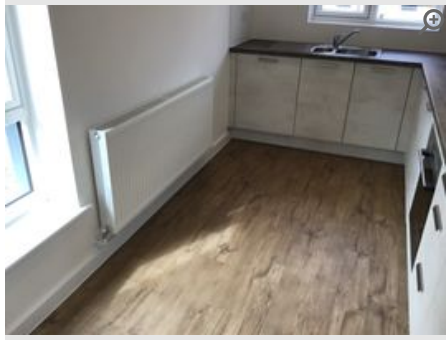
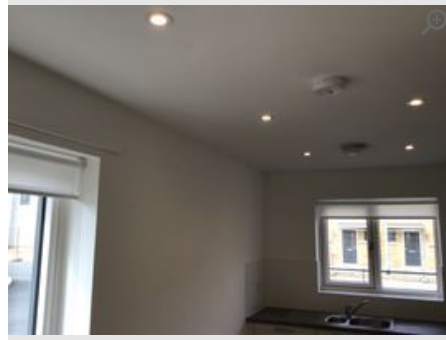
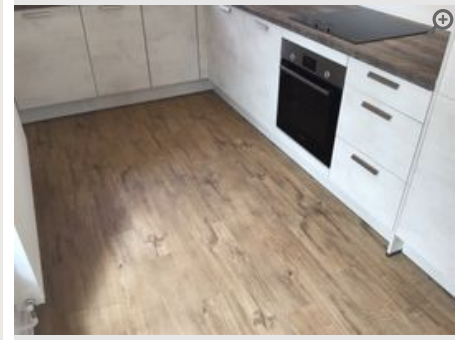
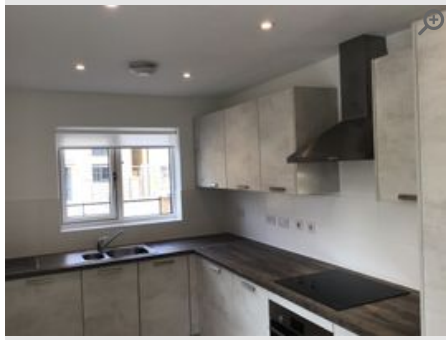
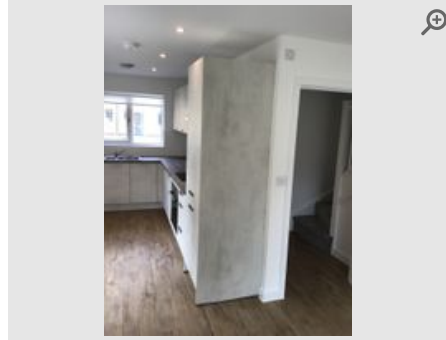
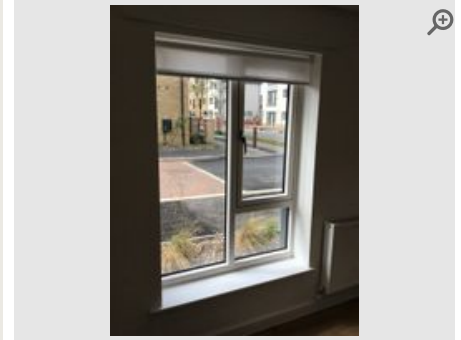
Item	Description	Condition	Cleanliness	Photos
4.1 General Overview	Clean & Tidy. Neutral smell/no odours evident Rear of cupboard under sink has black blotches. Left roller blind marked on bottom edge. Facing blind incorrectly fitted, hard to move, and marked on bottom edge. Right wall has scratches near top of extractor, ceiling marked above.	● Good	● Good	📷 10 photos

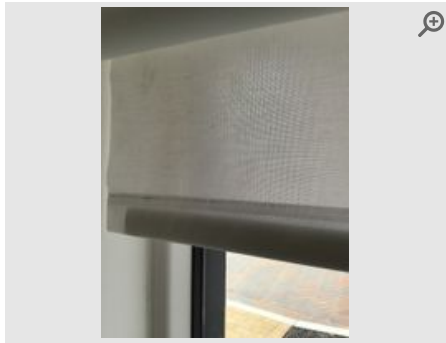
Provided by	Inspector
Captured (via App):	27/08/2024 11:57 AM
Added	27/08/2024
Reference	4.6.1

4.5 Walls	Plastered & painted white. Tiled (around worktops). Tiled splashback (behind cooker). Yellow	● Good	● Good	📷 2 photos
4.6 Windows and Sills	Standard window. 2 in total. UPVC double glazed. Clear glass. Keys not present. Chrome handle. Wooden sills. Tiled sills. Roller blind. Fabric blind. Trickle vents present. Sills free of marks. Windows intact. Frames free of marks. Opening Mechanism functioning. White blinds	● Good	● Good	📷 8 photos
Information provided by inspector: Roller blind over sink needs reseating.				
🔴 Landlord responsibility				🔧 Repair

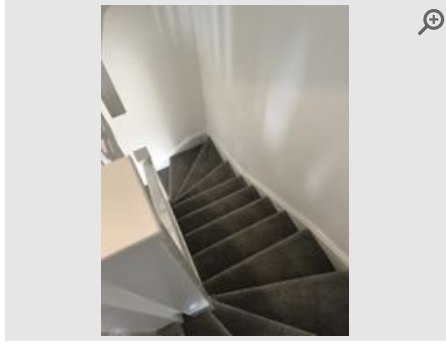
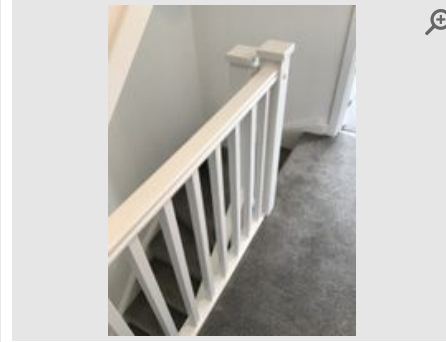
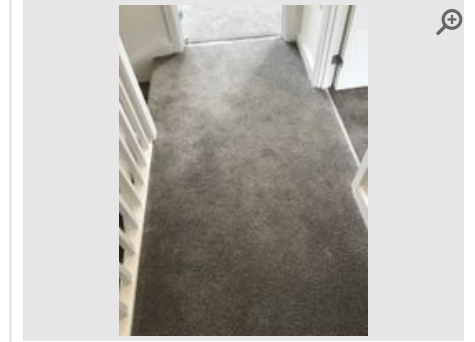
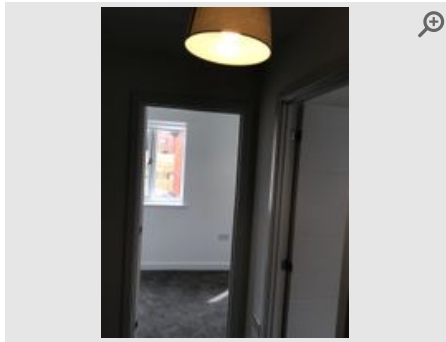
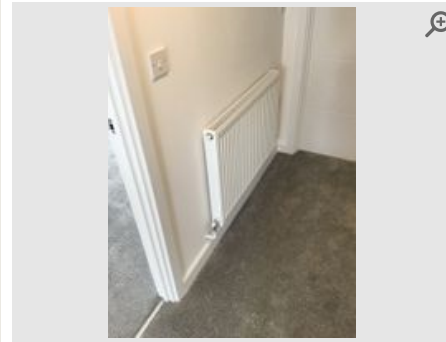
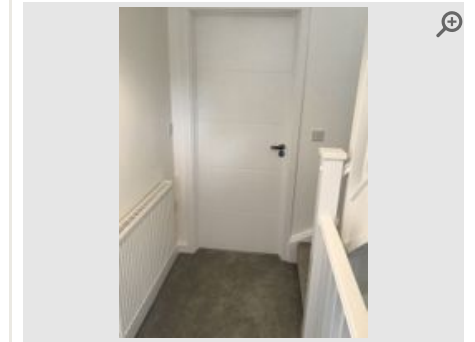
**General
Overview**

Item	Description	Condition	Cleanliness	Photos
5.1 General Overview	Clean & Tidy. Neutral smell/no odours evident Handrail is scuffed near lower newel post.	● Good	● Good

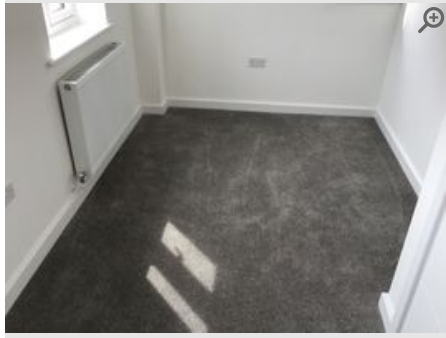
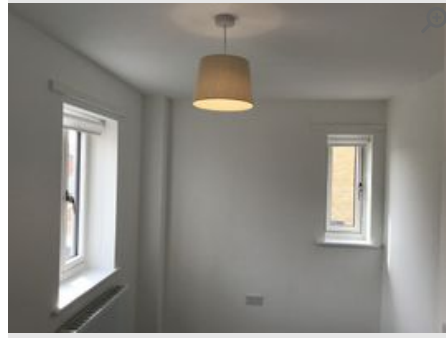
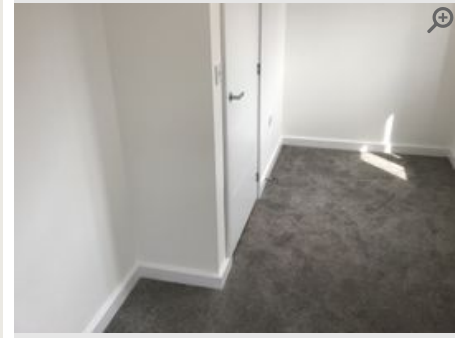
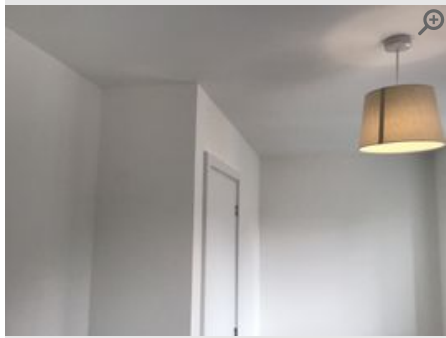
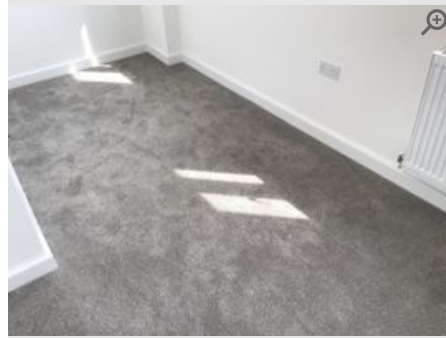
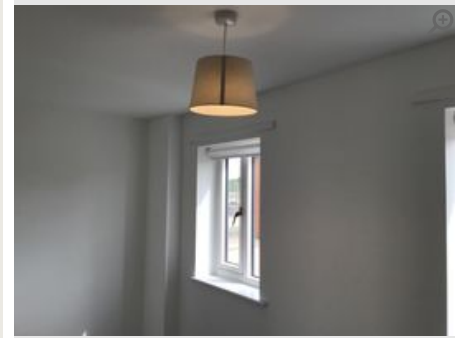
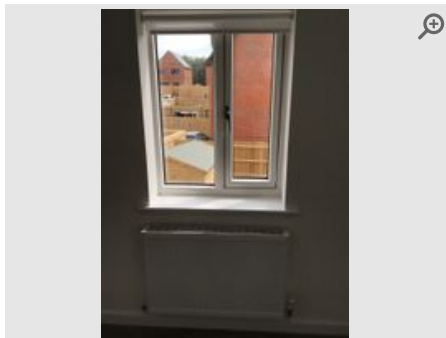
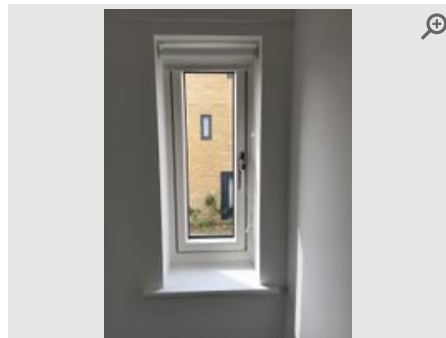
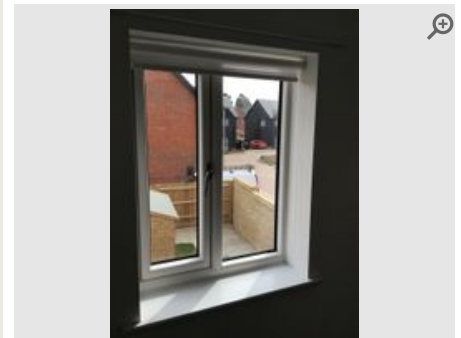
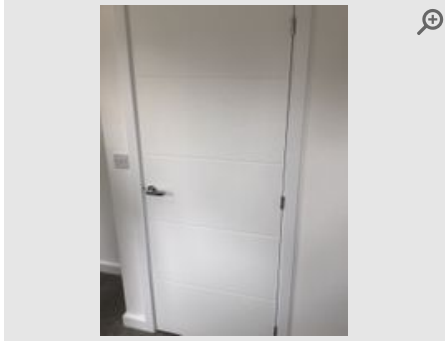
Item	Description	Condition	Cleanliness	Photos
6.1 General Overview	Clean & Tidy. Neutral smell/no odours evident All 3 roller blinds have marks on bottom edges. Left facing blind is seated incorrectly, hard to open.	● Good	● Good	📷 10 photos

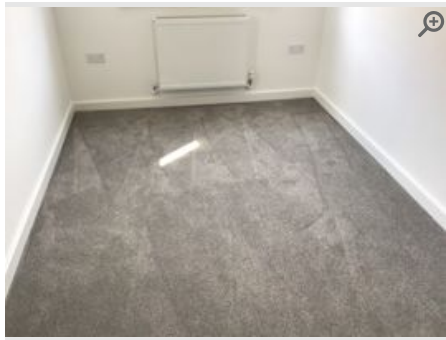
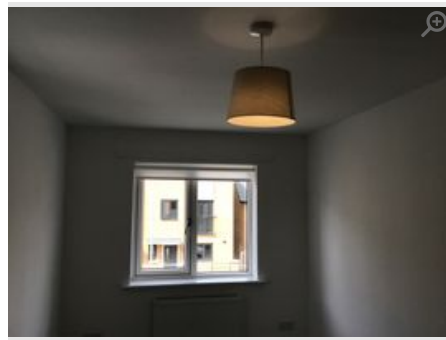
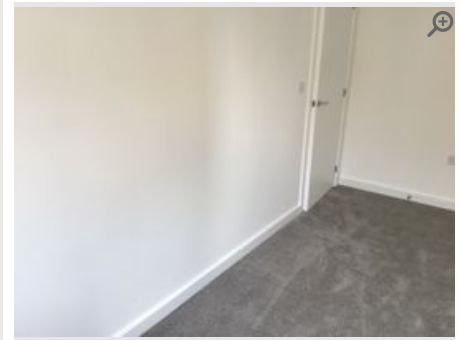
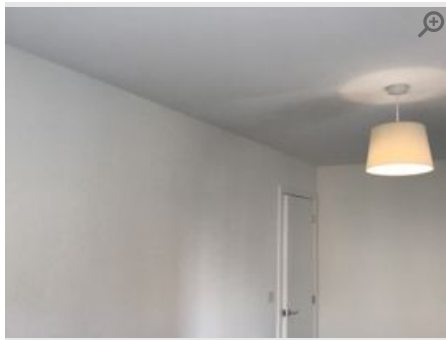
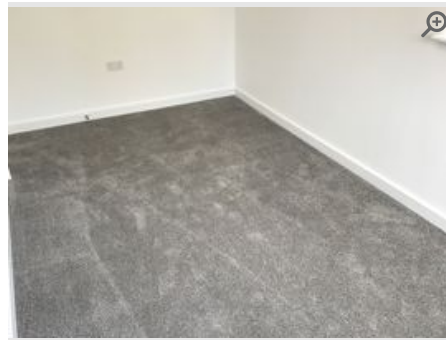
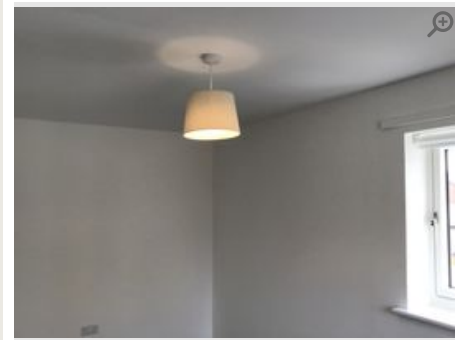
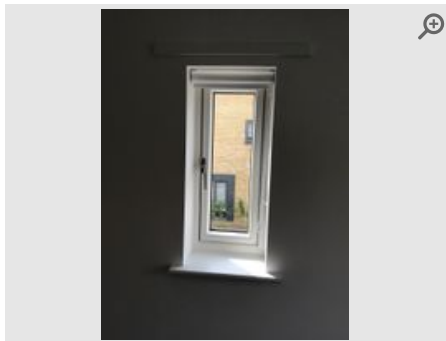
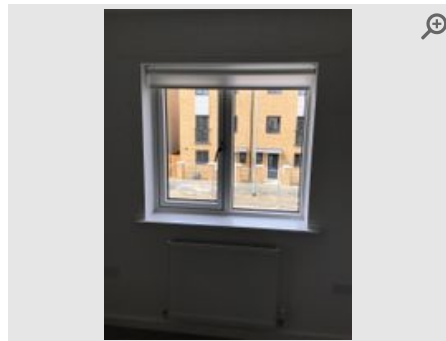
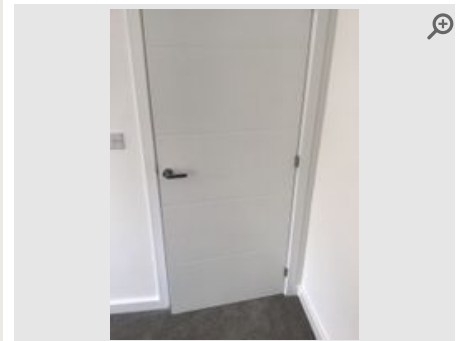
Item	Description	Condition	Cleanliness	Photos
7.1 General Overview	Clean & Tidy. Neutral smell/no odours evident Right door frame chipped to upper part. Both roller blinds have paint marks on lower edges. Front blind will not open and close.	● Good	● Good	📷 9 photos

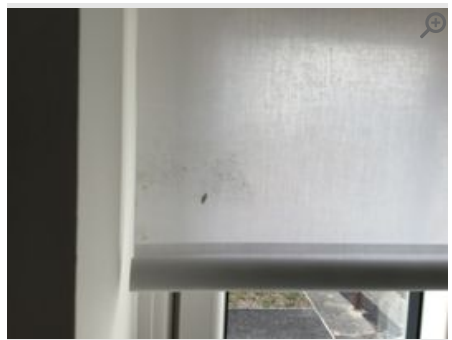
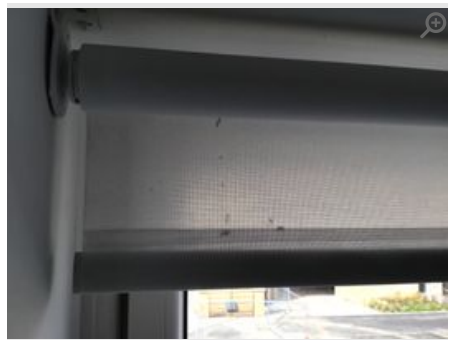
7.7 Walls	Plastered & painted white	● Good	● Good	📷 N/A
7.8 Windows and Sills	Standard window. 2 in total. UPVC double glazed. Clear glass. Keys not present. Chrome handle. Wooden sills. Roller blind. Fabric blind. Trickle vents present. Safety device present. Sills free of marks. Windows intact. Frames free of marks. Opening Mechanism functioning. White blinds	● Good	● Fair	📷 3 photos
	Information provided by inspector: Front roller blind incorrectly fitted, will not easily open.			
	🔧 Landlord responsibility			🔧 Repair

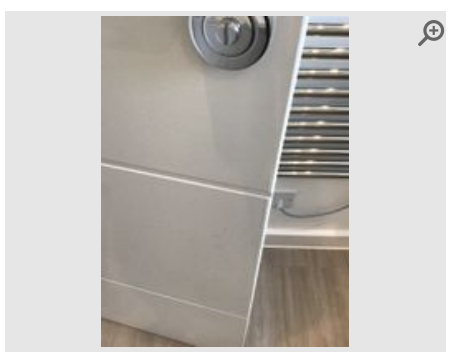
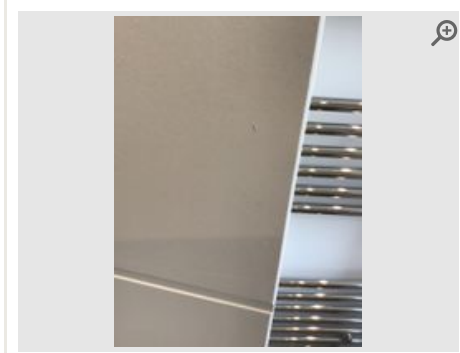
Door
(Internal)

Item	Description	Condition	Cleanliness	Photos
8.1 General Overview	Clean & Tidy. Neutral smell/no odours evident Front of door scuffed below handle with small chips above. Paint mark on radiator.	● Good	● Good	📷 N/A

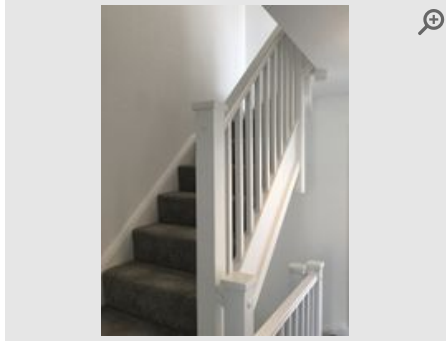
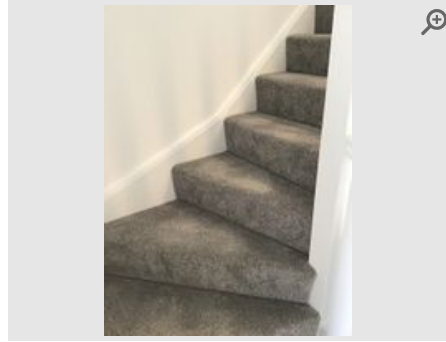
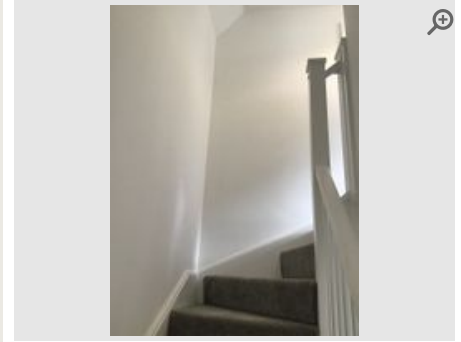
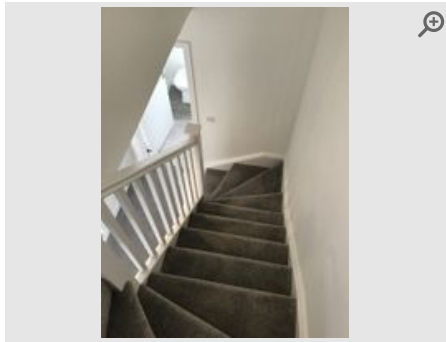
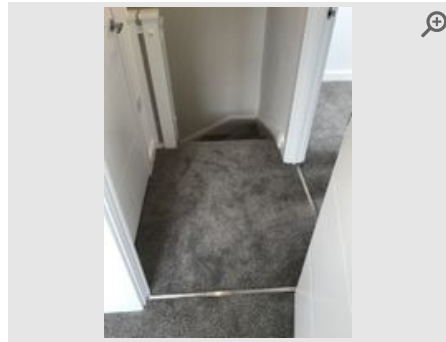
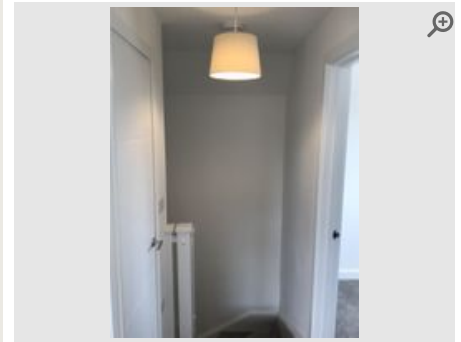
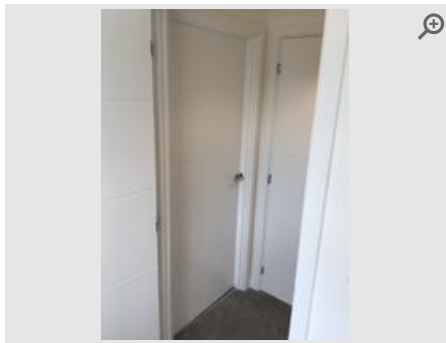
Item	Description	Condition	Cleanliness	Photos
9.1 General Overview	Clean & Tidy. Neutral smell/no odours evident Lower newel post marked on edge. Handrail marked on edge.	● Good	● Good

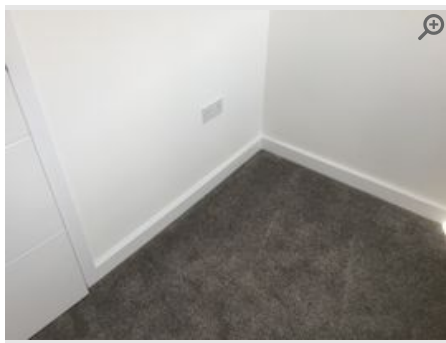
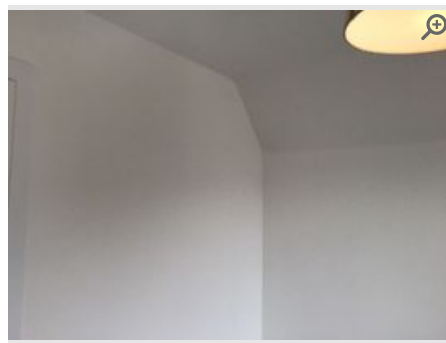
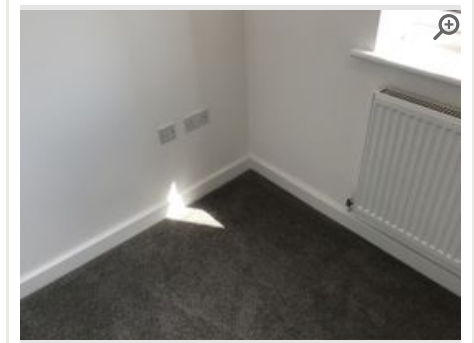
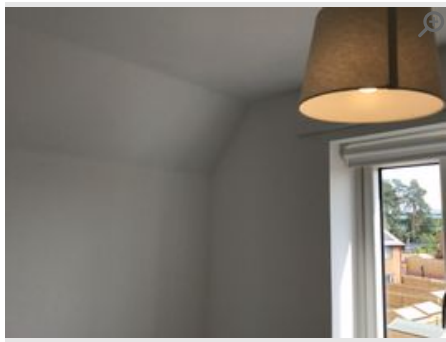
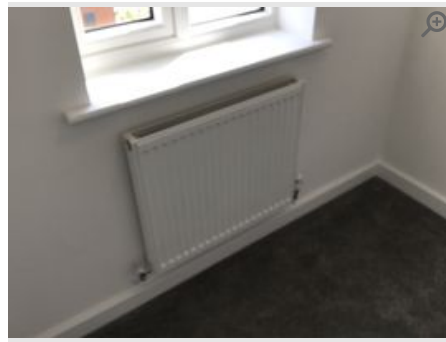
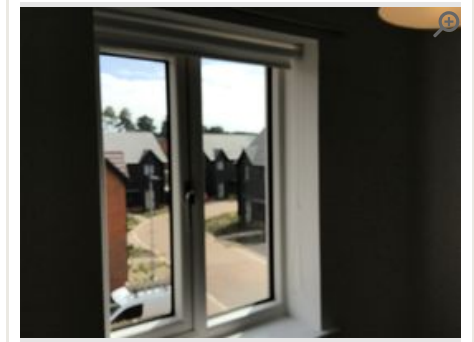
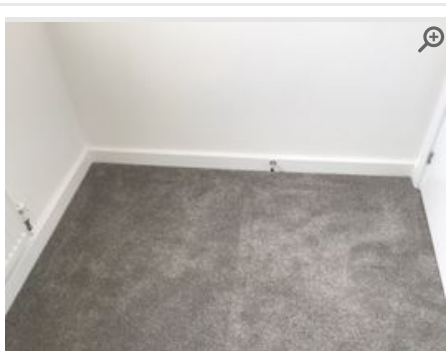
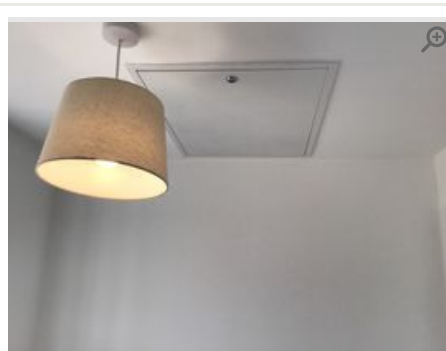
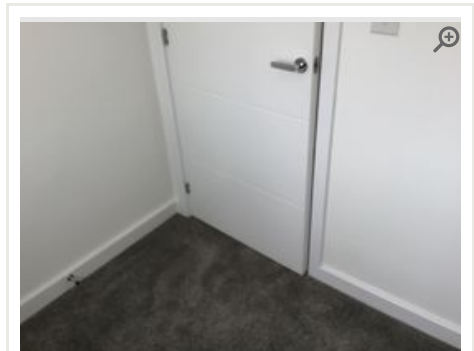
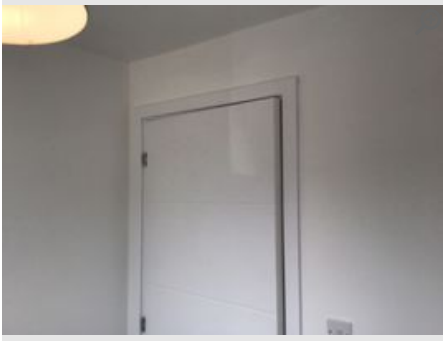
Item	Description	Condition	Cleanliness	Photos
10.1 General Overview	Clean & Tidy. Neutral smell/no odours evident Paint marks on bottom of roller blinds.	● Good	● Good

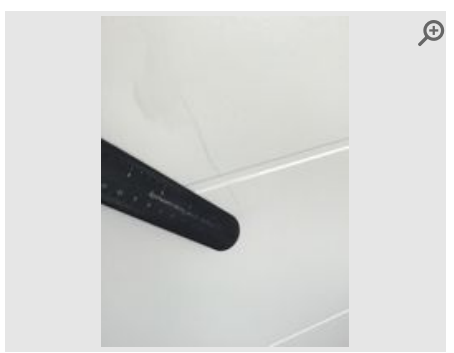
Door
(Internal)

Item	Description	Condition	Cleanliness	Photos
11.1 General Overview	Clean & Tidy. Neutral smell/no odours evident Gouge on front of door to centre left. Front casement handle is pitted. Gouge in ceiling to centre.	● Good	● Good	📷 N/A

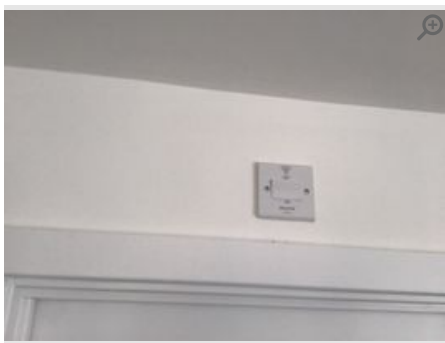
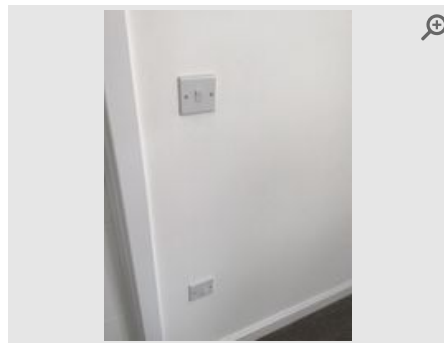
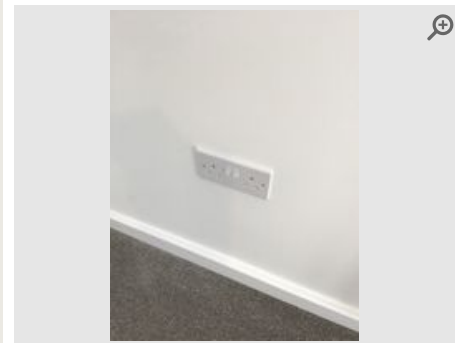
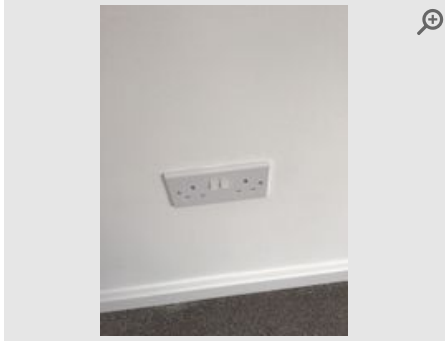
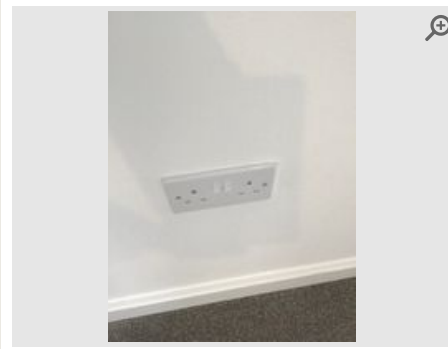
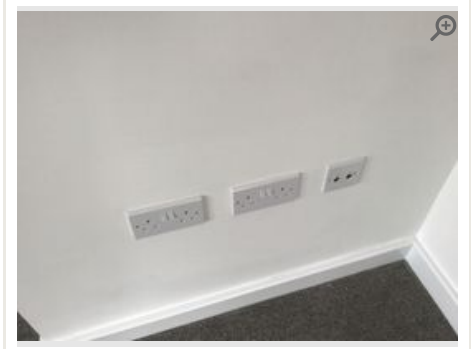
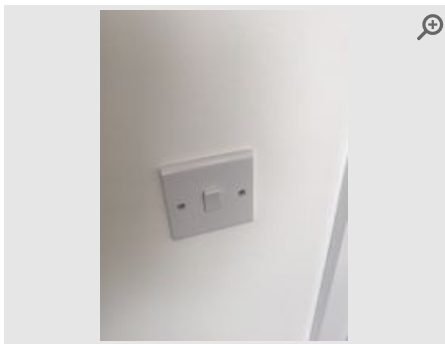
11.9 Radiator	White panelled. 1 in total. Thermostatic valve intact. Valve cap(s) intact	● Good	● Good	📷 N/A
11.10 Sockets & Switches	All sockets/switches plastic. 10 in total All sockets and switches present and intact with no signs of damage.	● Good	● Good	📷 7 photos

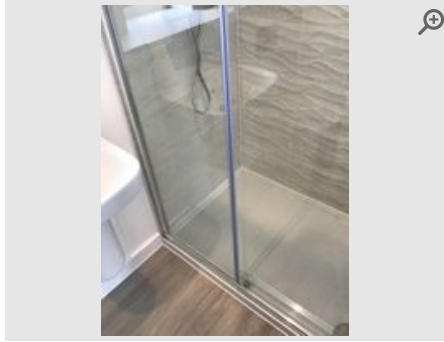
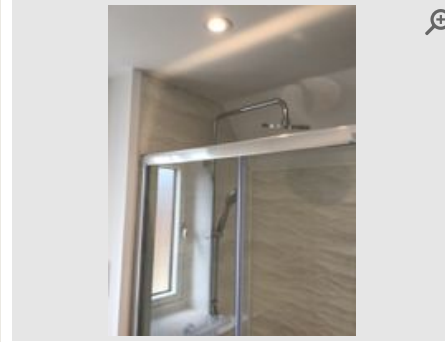
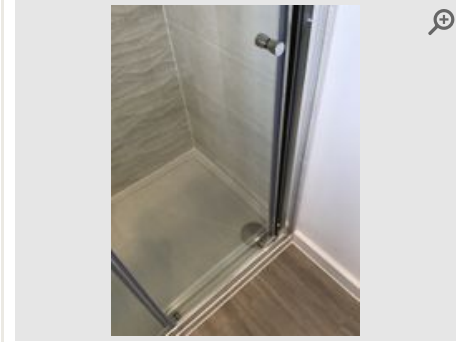
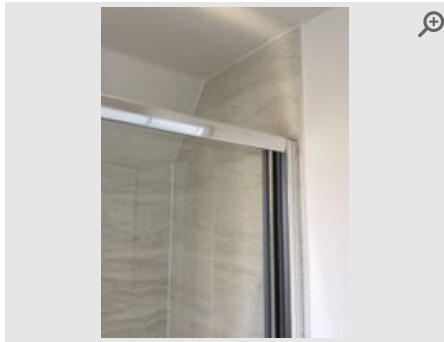
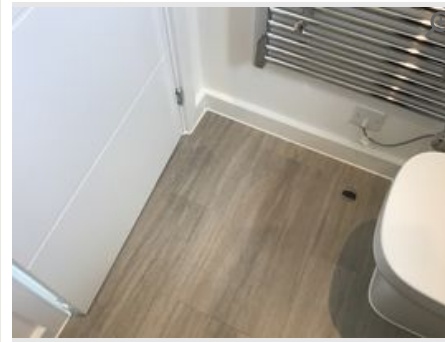
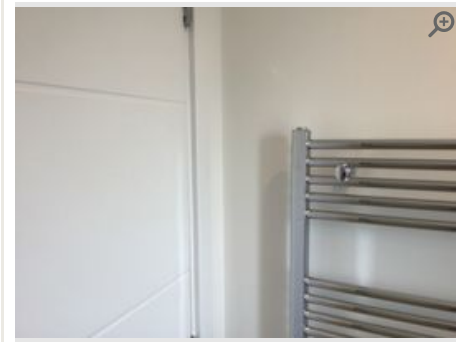
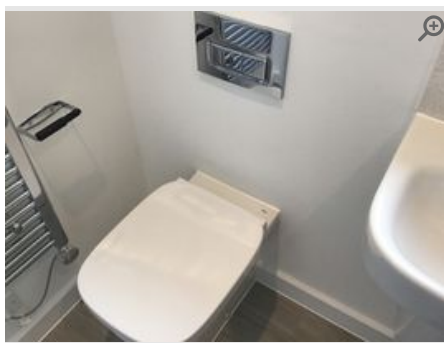
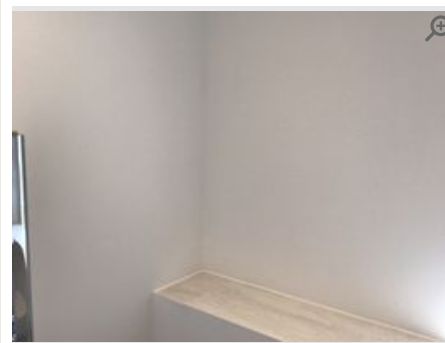
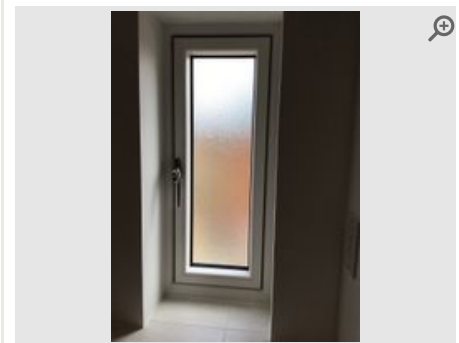
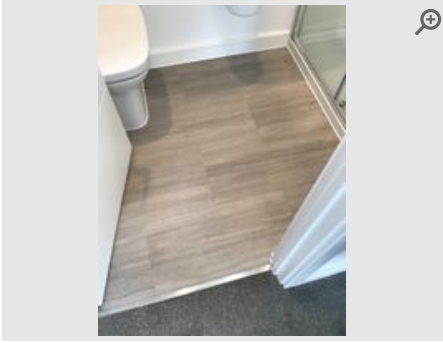
Item	Description	Condition	Cleanliness	Photos
12.1 General Overview	Clean & Tidy. Neutral smell/no odours evident Paint drips on radiator.	● Good	● Good	  10 photos

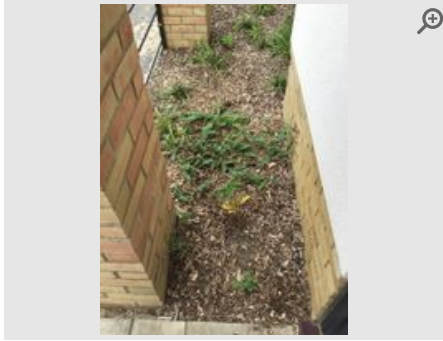
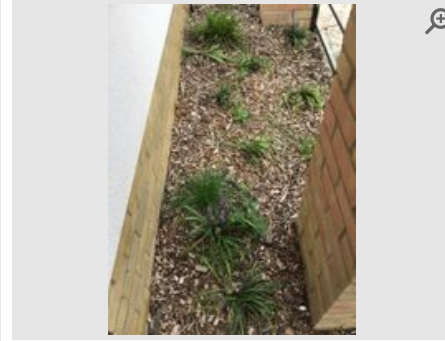
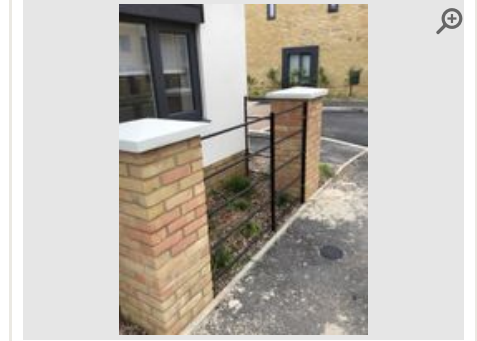
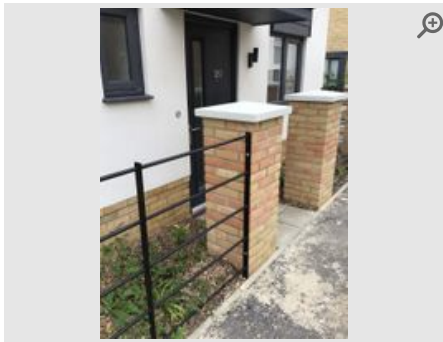
Item	Description	Condition	Cleanliness	Photos
13.1 Overview (External)	Good seasonal order. Weed free. Numerous weeds present. Pruned & trimmed plants. Boundary wall intact	● Good	● Good	📷 4 photos

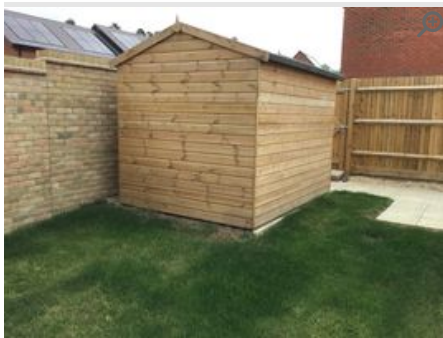
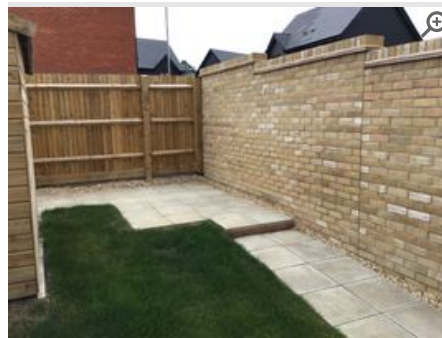
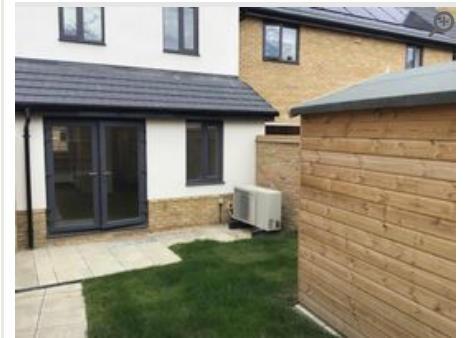
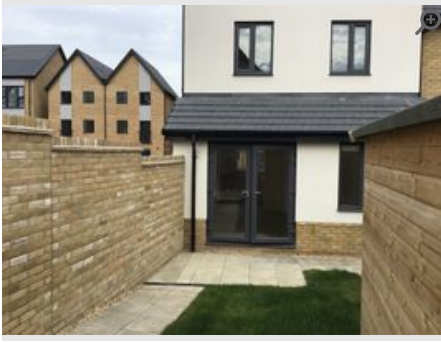
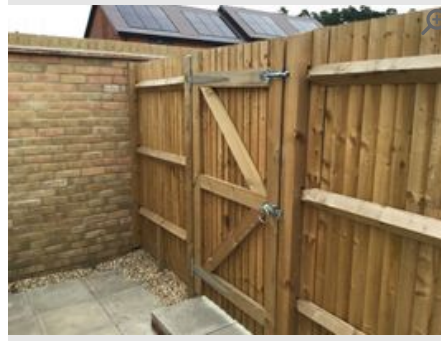
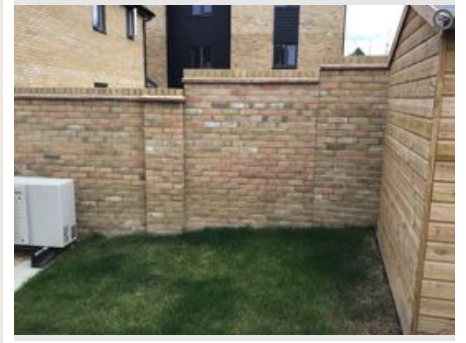
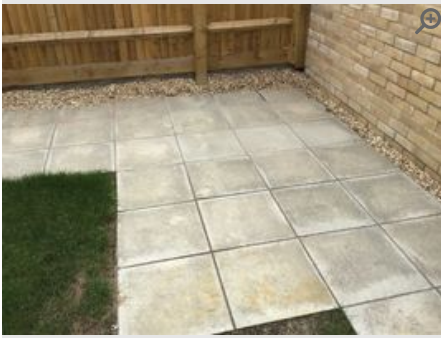
Item	Description	Condition	Cleanliness	Photos
14.1 Overview (External)	Good seasonal order. Grass over 1.5 inches long. Patchy area. Weed free. Paved area. Slabs intact. Fence panels. Fence panels appear secure. Fence posts intact. Boundary wall intact. Gate present. Gate intact. Shed present	● Good	● Good	📷 7 photos
14.2 Shed	Wood (Feather Edge). Felt roof. Hinged door. Latch intact. Free of items inside Secure fitting for bike.	● Good	● Good	📷 5 photos
14.3 Daikin Air conditioning unit		● Good	● Good	📷 1 photo
14.4 Outside Tap - WATER TEST	Taps have been run for 5 minutes.	● Good	● Good	📷 1 photo
14.5 Charging Point		● Good	● Good	📷 1 photo

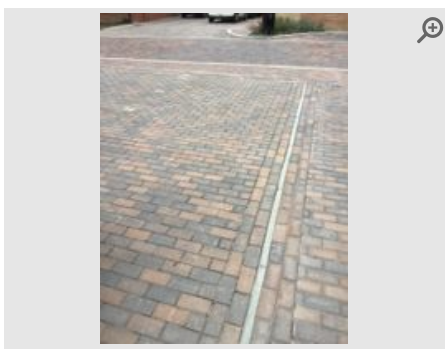
Item	Description	Condition	Cleanliness	Photos
15.1 Overview (Parking Space)	Block paved area. No markings. Free of oil/paint stains	● Good	● Good	📷 1 photo
